检测报告  
Test Report

| Sample Name | Circular Connector |
| Model No. | M12 |

测试项目：IPX7  
Test Item: IPX7

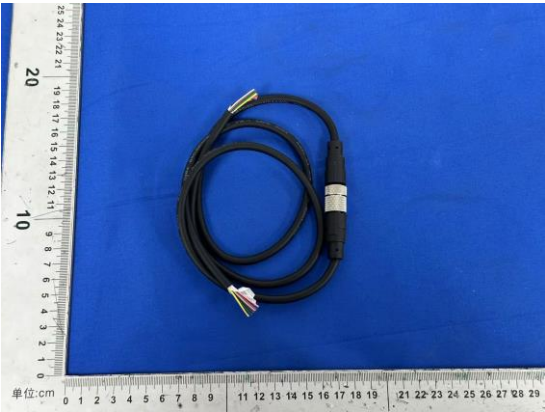
A2240783758101001

样品图片

Sample Photo(s)

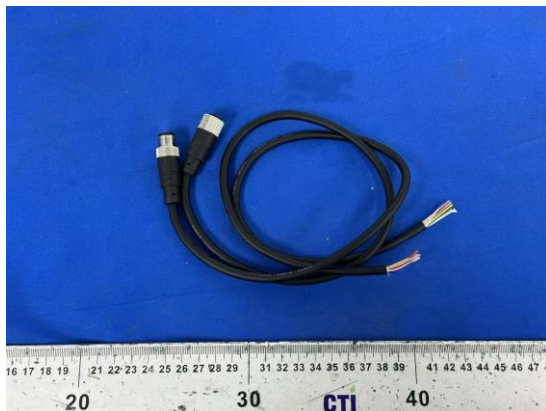
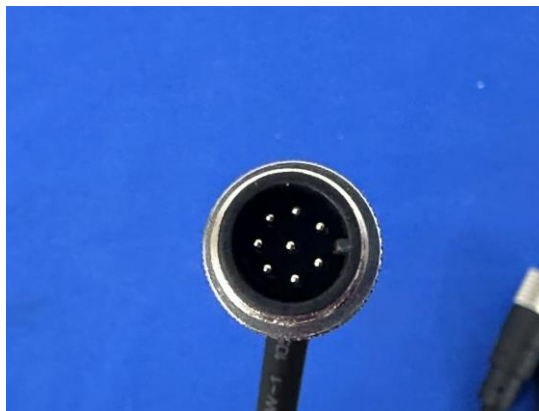
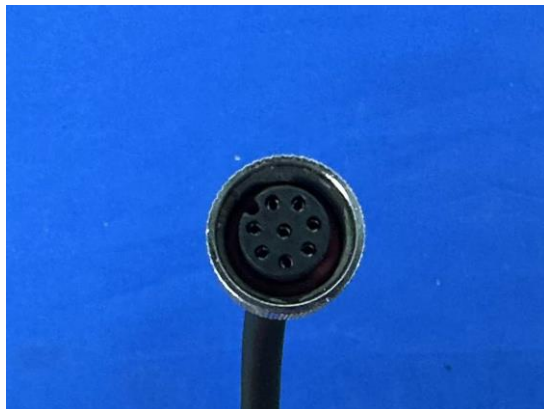
| 样品编号<br>Sample No. | 判定依据<br>Criterion | 测试结果（目视检查）<br>Test result（Visual inspection） | 结论<br>Conclusion |
|---|---|---|---|
| A2240783758101001 | 样品内部无水进入<br>No water enters the sample | 样品内部无水进入<br>No water enters the sample | 符合<br>Pass |

测试后样品图片

Sample Photo(s) after the test
